Manhole Inspection Summary

Manhole # S11O__023MH

Insp Date: **4/14/08 2:36 PM**

Location Address: **3215 Stafford St**

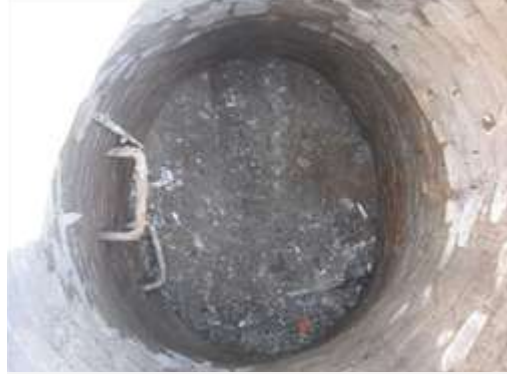
Top View

Heavy sediment on bench and in channel

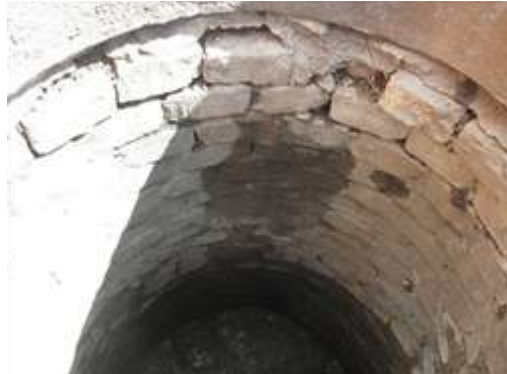
Defect 3

Active infiltration along corbel wall

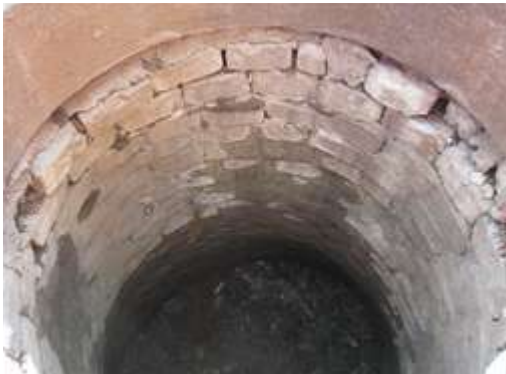
Defect 2

Loose bricks and mortar under frame/evidence of corbel and barrel infiltration

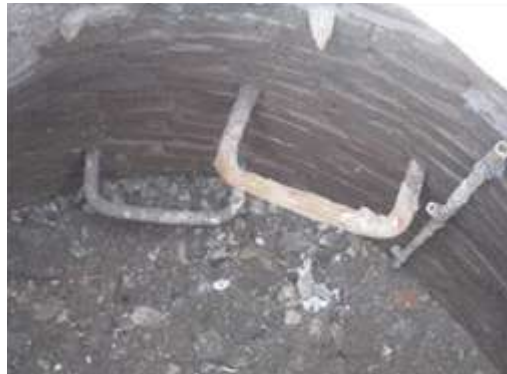
Defect 1

Corroded steps (1 missing)/barrel infiltration

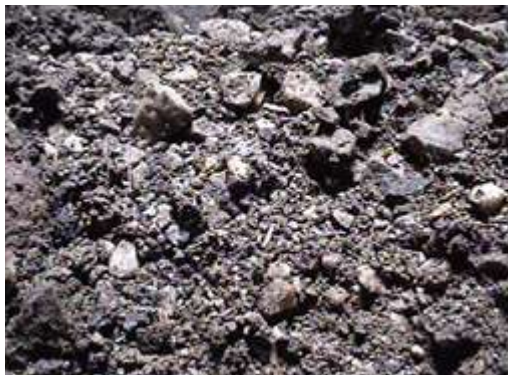
Defect 4

heavy deposits in manhole (approximately 12")...

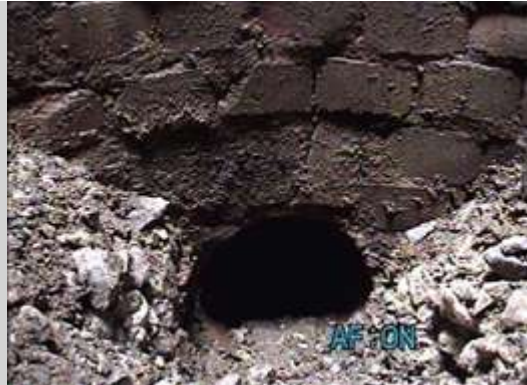
12 O'Clock Outflow

Deposits: ☐ None ☐ Mud ☐ Sludge ☒ **Debris** ☐ Grease

Silt Depth: **12** (in.) Deposits Extent: **Heavy**
